Innovative coating for Electroplated Hard Chromium replacement in severe environments

L. Fabiocchi, N. Lecis, K. Mounir

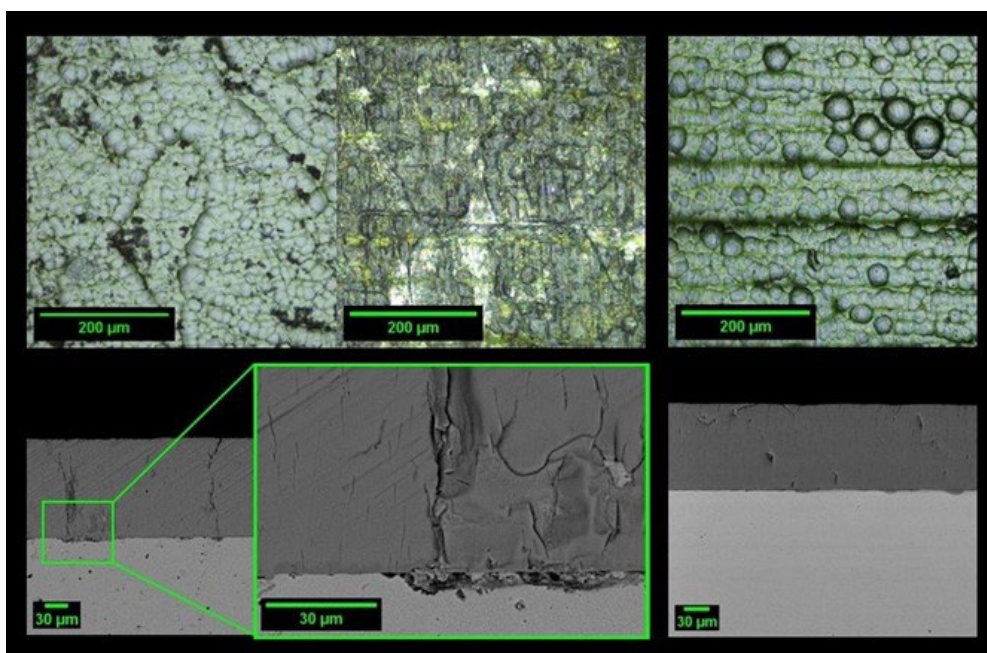
Fig.1 - Surface and cross section of EHC coatings: Cr140FC on the left and Cr90N on the right.

As can be seen in Fig.1, the coating surface of Cr140FC have the typical cracks of the EHC, moreover scratches and abraded zones are also visible. Transversal cracks along the entire coating thickness are visible in the cross

section of the sample, while these are reduced in Cr90N. The average values of the mechanical test results are reported in the Tab.2.

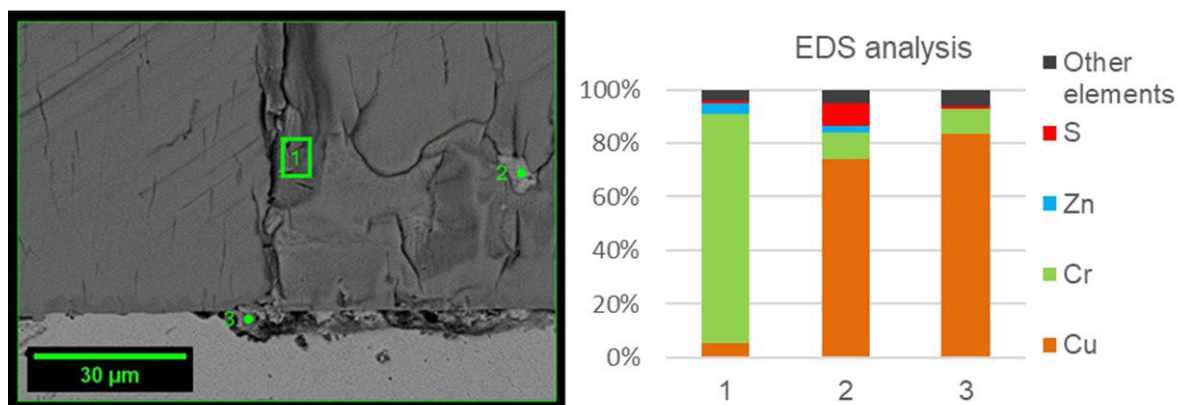
Since metallic elements not belonging to the nominal composition of the materials were individuated inside the transversal cracks of Cr140FC (see Fig.2), a zinc test was

Fig.2 - Coating defect of sample Cr140FC (left) and EDX analysis of the infiltrated elements.

From the results of the analysis on Cr140FC it was clear that infiltration of zinc and sulphur, with the subsequent formation of intermetallics with the copper substrate, was the principal cause of the coating failure together with the mechanical stresses leading to transversal cracks formation. These connect the substrate to the external part of the coating, thus hindering the shielding ability of the material.

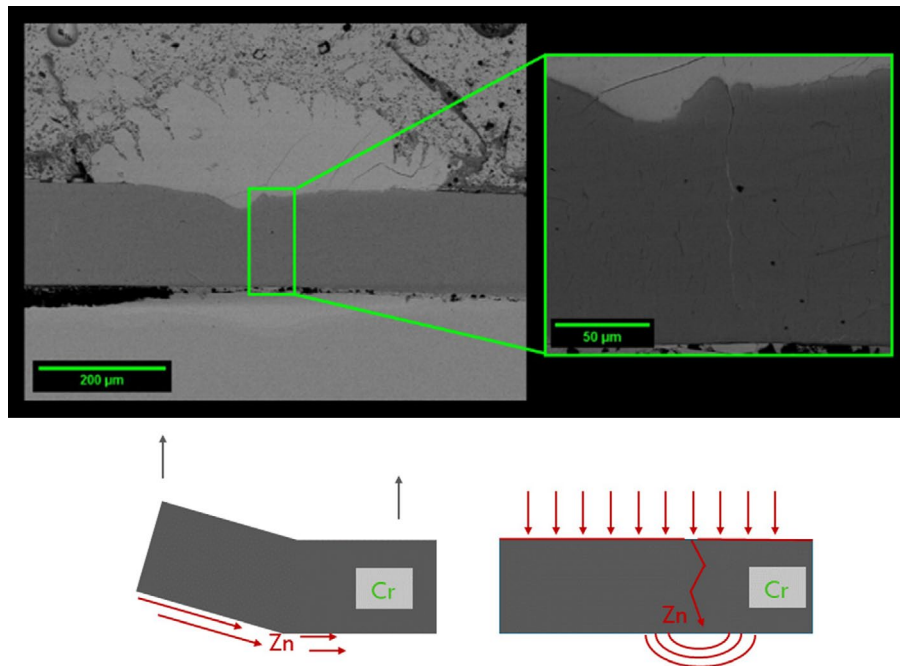
performed on both samples. In both samples delamination was observed after immersion in the molten metal, as can be observed in Fig.3.

Fig.3 - SEM images and scheme of the infiltration mechanism of Zn for the EHC coating.

The zinc test confirmed the coating failure mechanism: fragile copper-based intermetallics containing mostly sulphur and zinc formed due to the molten metal penetration through the hard chromium microcracks and, they weakened the interface, finally leading to coating delamination owing to the pressure generated

by the volume of liquid itself. In the case of Cr140FC, the effect of compressive and shear stresses on the surface during wear tests allowed a partial microcracks closure, thus delaying the infiltration of the molten metal and the consequent chemical attack mechanism.

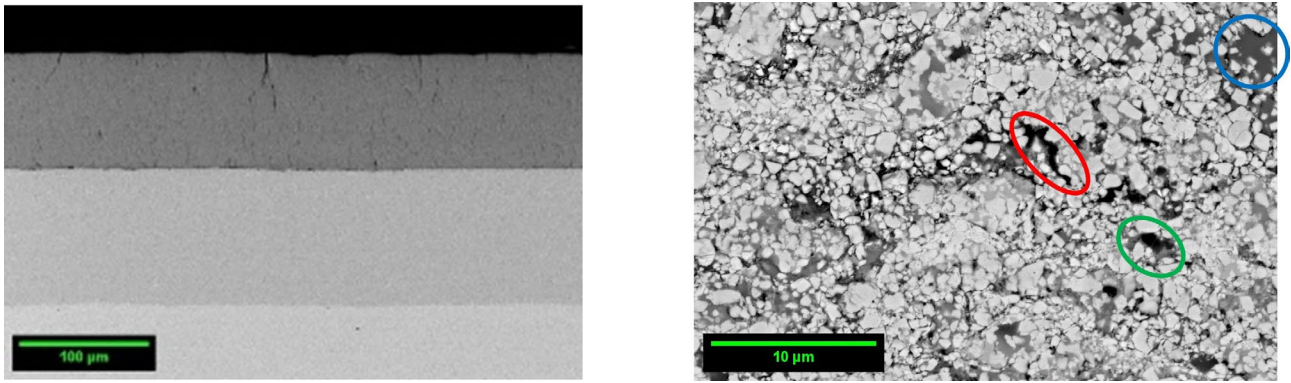
For the NiCr90N coating, micrographs in Fig.4 display the difference between the electrodeposited chromium and the electrodeposited nickel layers: the former features pores and microcracks, the latter is compact.

All thermal spray coatings showed thickness and composition inhomogeneities: the former is more evident for the HVOF WC-23CoN and for the samples with lower thickness, while the latter is present in all samples since it is an intrinsic characteristic of the deposition process. In particular, cobalt and chromium rich islands were detected.

Fig.4 - NiCr90N double layer coating, from top to bottom: Cr layer, Ni layer and Cu substrate (left). WC-10Co5CrNgrad coating microstructure inhomogeneities, indicated by the red circle for Fe particles, blue for Co-rich and green for Cr-rich pools.

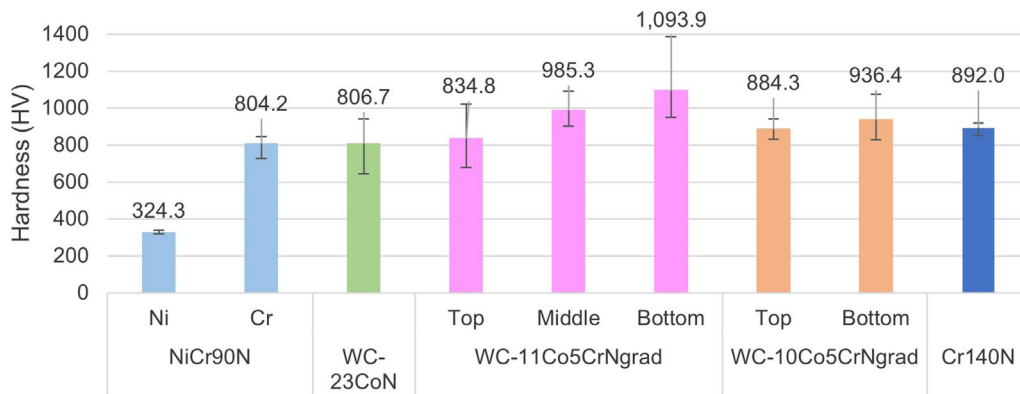
The difference in the compositions is reflected in the hardness values: even though WC-23CoN has a similar thickness to WC-11Co5CrNgrad middle and bottom sections and WC-10Co5CrNgrad bottom part, its hardness is slightly lower due to the reduced carbide fraction (Fig.5). Considering the three sections of WC-11Co5CrNgrad, it can be noticed an increasing thickness accompanied by a coherent trend in the coating and in the substrate hardness. Substrate of thicker thermal spray coatings are, in fact, subjected to high temperature and

Fig.5 - Coating cross section hardness comparison using a load of 300 gf.

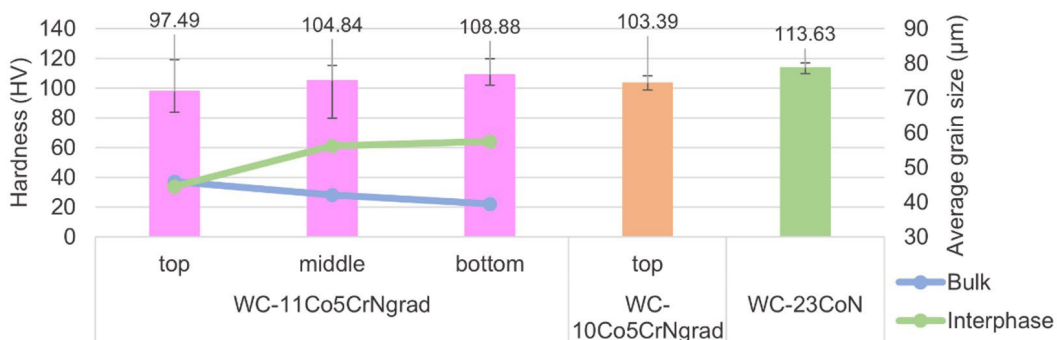
compressive stresses for a prolonged time, inducing recrystallization and plastic deformation at the surface, which is reflected on the average grain size at the interface coating-substrate (Fig.6). NiCr90N, WC-23CoN and WC-11Co5CrNgrad top have lower coating hardnesses, but they are still comparable to EHC.

Fig.6 - Substrate hardness comparison using a load of 100 gf and corresponding average grain size for the sample WC-11Co5CrNgrad.

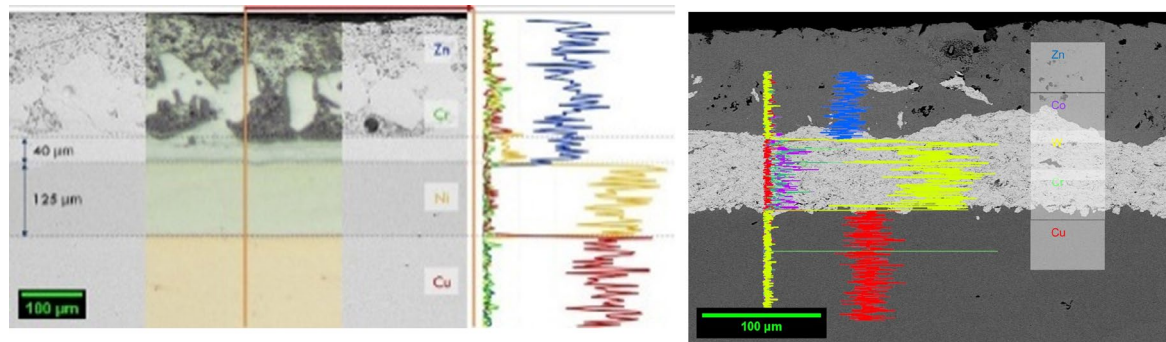
All thermal spray coatings showed an excellent resistance to zinc corrosion with the exception of the thinner sample of WC-11Co5CrNgrad, while NiCr90N revealed a peculiar behaviour. In this case, the chromium layer

was completely delaminated, however the nickel layer succeeded in protecting the copper substrate, consequently no detrimental intermetallic phase was formed below the coating.

Fig.7 - NiCr90N EDX line analysis (left). WC-11Co5CrNgrad middle EDX line analysis.

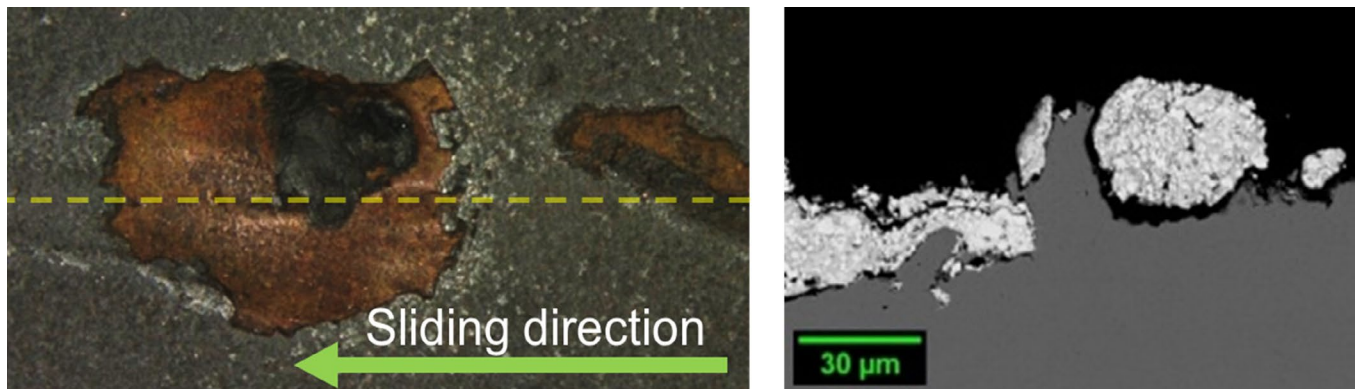
WC-Co-HVOFused was studied only by optical and chemical analysis. The proposed failure mechanism was attributed firstly to the insufficient coating thickness, that led to the deformation of the ductile substrate, as can be seen in Fig.8. After reaching critical deformation, brittle

cracking of the ceramic coating initiates at the surface. Consequently, stressed copper was then "extruded" and attacked by detrimental elements, mainly sulphur and traces of zinc.

Successively, crack opening and penetration of metals

under the coating in the weak spots occurred, leading to coating delamination caused by weak interphases and mechanical forces at the surface, as well as cohesion failure and erosion.

Fig.8 - WC-Co-HVAFused defect (left). Detail of defect cross section (right).

Adjusting the thickness and toughness of thermal sprayed cermet coatings is essential for their use in severe wear and temperature environments. Further research is needed to optimize the coating composition and to limit the costs for high thickness.
